FINAL INVESTIGATION REPORT

ACCIDENT OF SUNWAY AIR CARRIER (GEORGIA)
IL-76TD AIRCRAFT REG # 4L-GNI AT KARACHI, PAKISTAN
ON 27th NOVEMBER, 2010

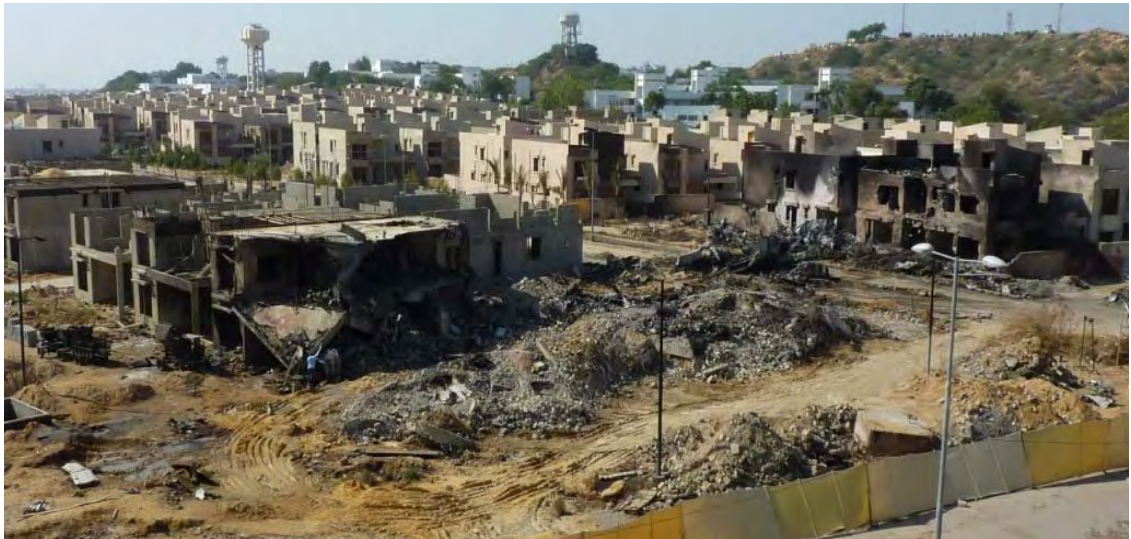
1.12. **Wreckage and Impact Information.** Most of the wreckage was located in an area approximately 150m (long) x 60m (wide). The aircraft crashed on under construction buildings and was in right bank before the impact. At the time of impact, aircraft heading was approximately 320-330 degrees. As a result of the aircraft's collision with the ground, under construction buildings and subsequent fire almost entire aircraft structure was destroyed. The following pictures explain location and condition of major parts as found after ground impact. The details are presented in the wreckage analysis report.

Aircraft crash site and wreckage

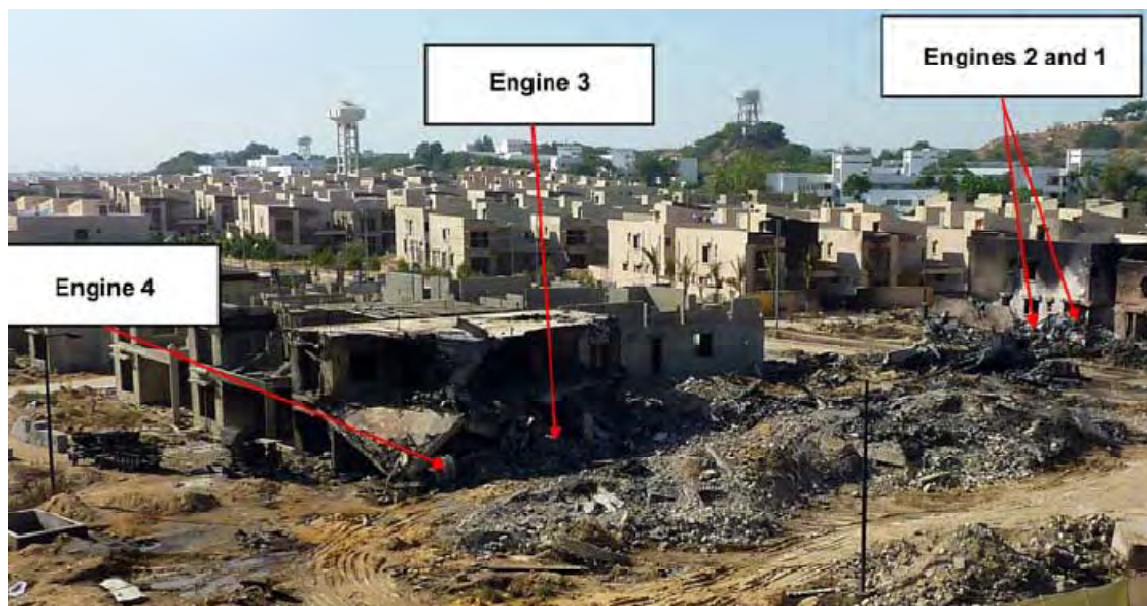
Location of engines

- 2.22.6. All four engines were found in the main wreckage of the crashed aircraft. However, some parts of Engine # 4 were found on the flight path of the aircraft after takeoff. The engine parts found before the main aircraft wreckage included, fragments of engine front cowl, fragments of inlet guided vanes, fragments of LP compressor 1st, 2nd and 3rd stage casing, LP compressor 2nd and 3rd stage blades, LP compressor 1st stage disk with broken shaft and LP compressor 2nd and 3rd stage disks. These parts were located at a distance of approximately 1900-2400 meters from the runway end and about 1200-1400 meters before the main aircraft wreckage. These fragments had signs of mechanical damage only, and no signs of thermal / fire damage. This indicates that some part out of these experienced uncontained failure and caused extensive damage to Engine # 4.

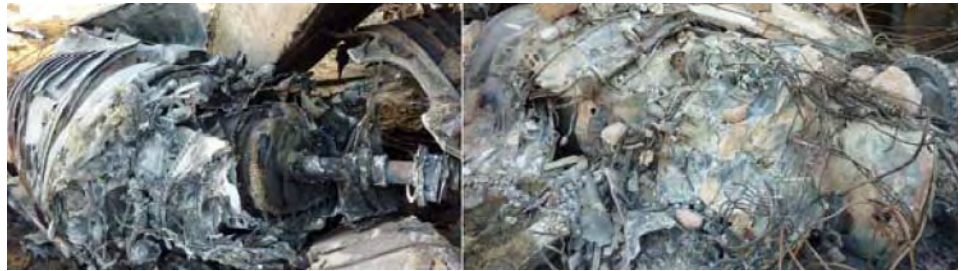
#4. Engine # 4
&
Engine # 3

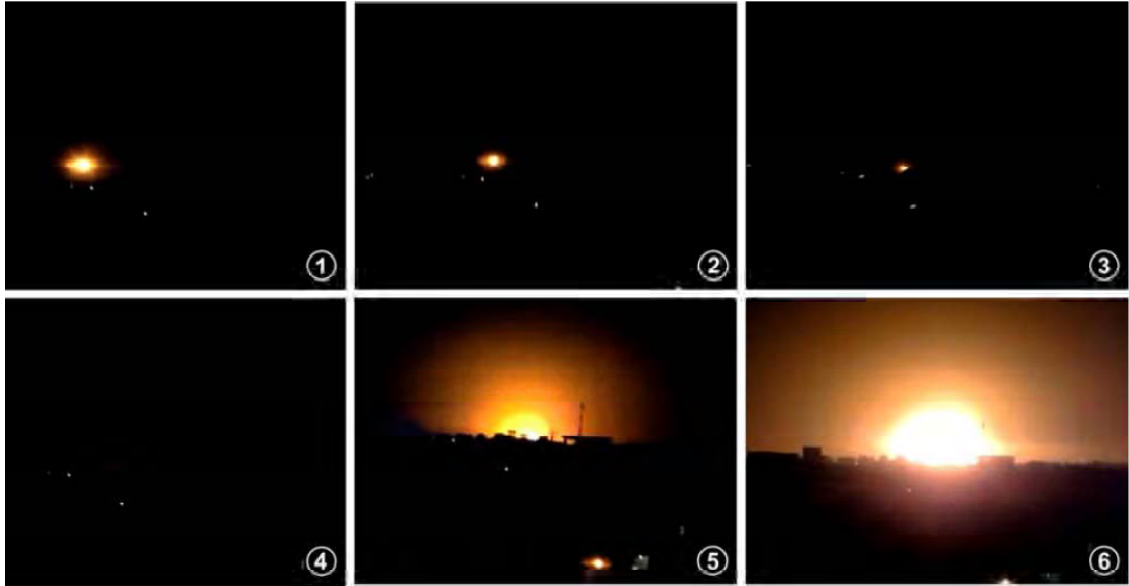
1.14.3. An amateur video also provided evidence that fire occurred onboard during climb after takeoff and continued till its impact with ground.

The amateur video record of mishap aircraft in-flight fire

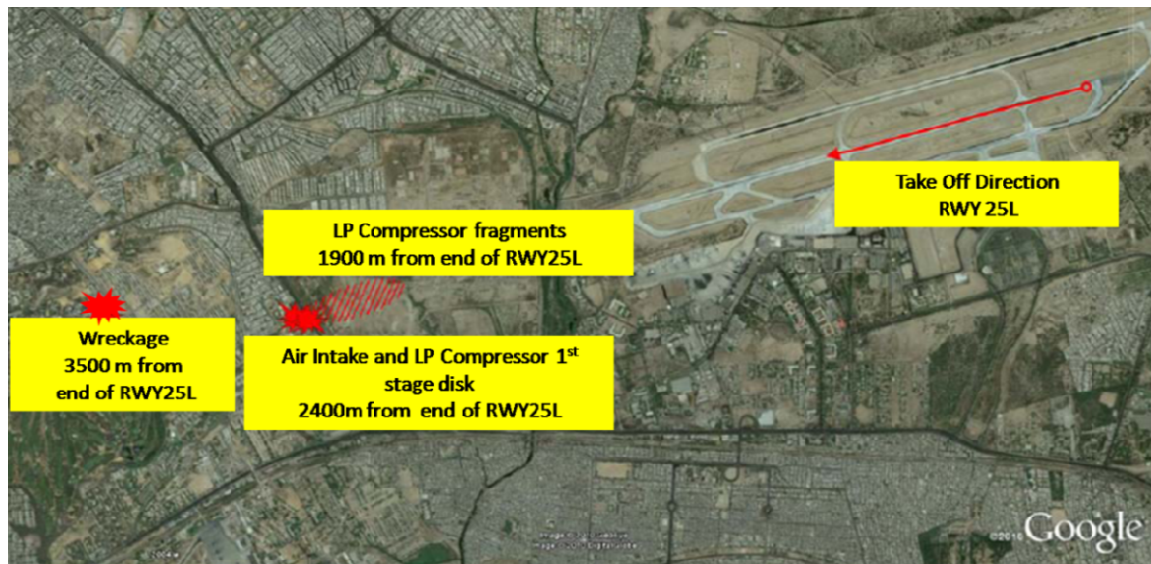
Engine # 4 fragments between the end of Runway 25L and crash site

- 2.22.7. Since the fragments of LP compressor 2nd stage disk were found approximately 1200-1400 meters before the main wreckage of the rest of the aircraft it was assumed that most probably it was the first component to fail. Most likely after failure of the LP compressor the LP turbine over speeded and its 6th stage disk disintegrated.

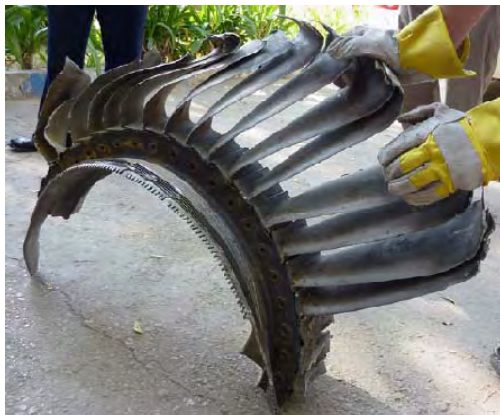
2.24.12. The fragment of the 2nd stage disk of the LP compressor was lost during the investigation. The fracture mode analysis was therefore, performed based on photographs of the damaged part.

The fragment of LP Compressor
2nd stage disk

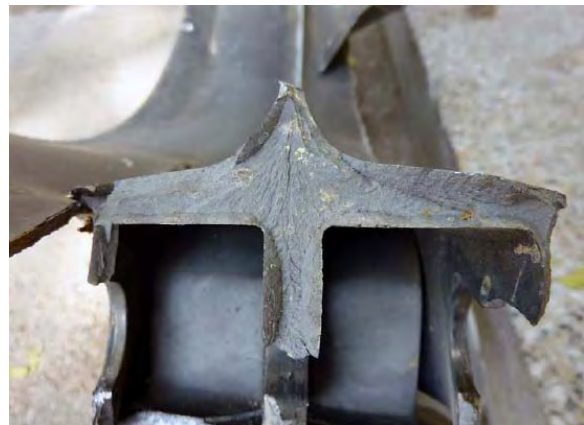
Fracture surface of LP Compressor
2nd stage disk.

2.24.14. No signs of plastic deformation of the cross-section at and around fracture surface.

2.24.15. No angularity caused by plastic deformation in the initial fracture zone.

2.24.16. Smooth surface region in the fracture initiation zone.

2.24.17. The macro lines indicating stops of crack front.

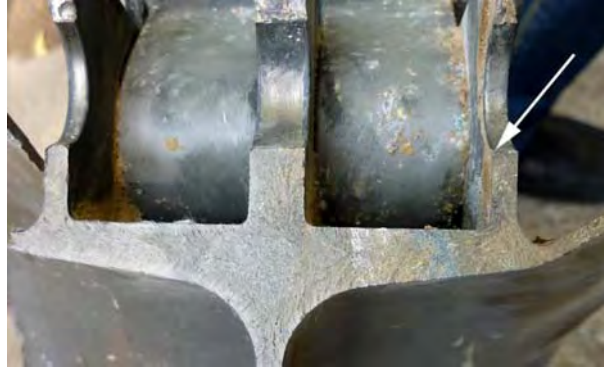
2.24.18. The fatigue crack in the disk of LP compressor 2nd stage started from the extreme edges of the hole of the disk. The hole is meant for installing the bushing for pin of compressor blades (picture below).

The arrow shows the place of a fatigue crack initiation on LP compressor 2nd stage disk

2.24.22. Since some fragments of LP compressor 2nd stage were not available, therefore, fatigue fracture could not be confirmed and was concluded as the most probable cause based on the available photographic evidence.

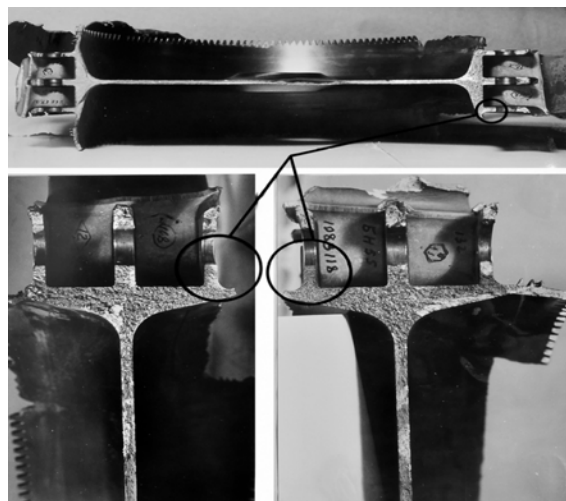
2.24.19. According to the data of the “State Centre for Flight Safety of Air Transport” of Russia, there had been cases of D-30 (Д-30) engine failures caused by fatigue fractures of the LP compressor 2nd stage disk. Fatigue cracks appeared because of fretting corrosion in the holes designed to install the bushings for pin of the compressor blades. Comparative analysis of disks fractures in previous cases and on the mishap aircraft Engine # 4 showed that they were of similar character. The picture below shows such fracture of an accident which occurred on 30th October, 1989.

LP Compressor 2nd Stage Disk Fracture : Accident on 30th October, 1989

2.24.20. This type of failure was discovered in 1992 and subsequently remedial measures were instituted vide bulletins # 252-БП-Г, # 287-БП-Г, # 300-БП-Г and # 281-БП-Г. All engine installed to IL-76 aircraft operating in the Russian Federation were modified to remove the defect in the time period between years 2000 to 2002.
